DEPARTMENT OF TRANSPORTATION

Quality Assurance and Source Inspection

Contract #: 04-0120F4Cty: SF/ALA Rte: 80 PM: 13.2/13.9File #: 1x.28**WELDING INSPECTION REPORT****Resident Engineer:** Pursell, Gary**Address:** 333 Burma Road**City:** Oakland, CA 94607**Report No:** WIR-016115**Date Inspected:** 03-Aug-2010**Project Name:** SAS Superstructure**OSM Arrival Time:** 700**Prime Contractor:** American Bridge/Fluor Enterprises, a JV**OSM Departure Time:** 1100**Contractor:** American Bridge/Fluor Enterprises, a JV**Location:** Job Site**CWI Name:** Tony Sherwood**CWI Present:** Yes No**Inspected CWI report:** Yes No N/A**Rod Oven in Use:** Yes No N/A**Electrode to specification:** Yes No N/A**Weld Procedures Followed:** Yes No N/A**Qualified Welders:** Yes No N/A**Verified Joint Fit-up:** Yes No N/A**Approved Drawings:** Yes No N/A**Approved WPS:** Yes No N/A**Delayed / Cancelled:** Yes No N/A**Bridge No:** 34-0006**Component:** OBG Section**Summary of Items Observed:**

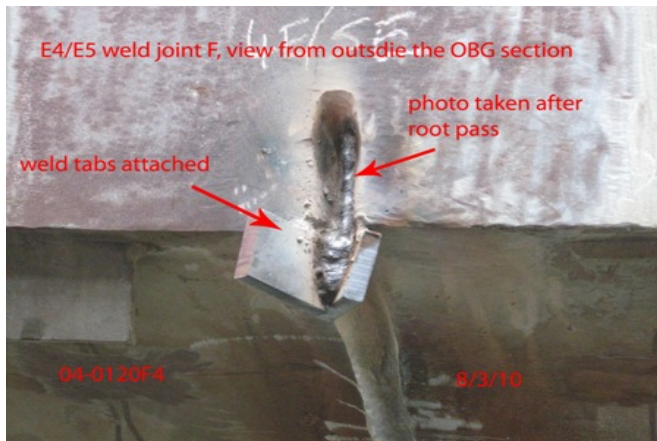
At weld joint E4/E5 – F, outside the OBG section this QA Inspector observed ABF welding personnel Fred Kaddu (# 2188) setting up to start welding the bottom section of the weld. This QA Inspector observed the weld area had been ground to facilitate welding and run off tabs had been attached. Please see photo below. The weld appeared to have been ground to sound metal. QC Inspector Tony Sherwood stated he had previously performed and accepted a visual and MT inspection of the weld area. Prior to welding this QA Inspector observed QC Inspector Tony Sherwood verify the following welding parameters: 125 amperes using a 3.2 mm diameter 7018H4R electrode. The welding observed appeared to comply with ABF-WPS-D15-1030-Rev-1.
